NMEO PROGRAM
ARA-I SHUTDOWN
Final Report

ARA-I HOT CELL
SHUTDOWN FINAL REPORT

This document presents a characterization of the ARA-I hot cell facility in its present shutdown condition.

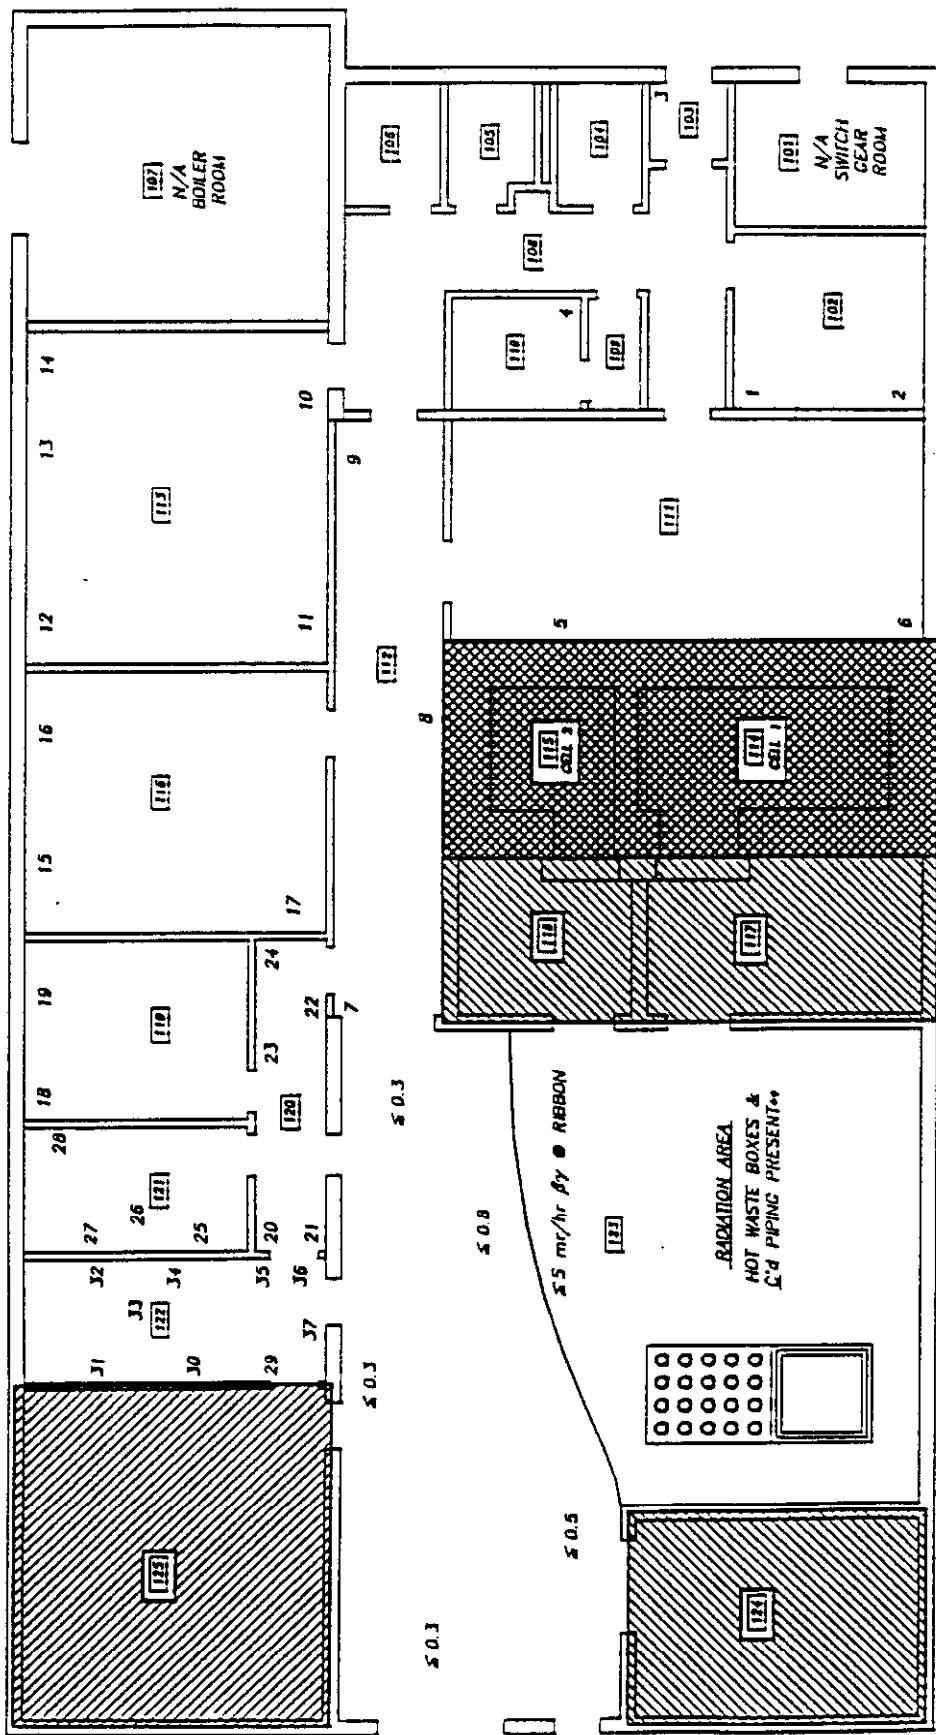
ARA HOT CELLS
 PLAN--FIRST FLOOR

#1-37 - FIXED C LEVELS PRESENT IN FACILITY (SEE ADDITIONAL PAGES)
 ** - IF BOXES IN RM #123 ARE REMOVED, ≤ 300 mc/hr $\beta\gamma$ @ CONTACT w/ BOXES
 GBF READINGS w/ GM ARE $< 0.1-0.2$ mc/hr $\beta\gamma$ w/ GM IN FACILITY

C ZONES/LEVELS AS FACILITY WAS LEFT
 SEALED AND/OR LOCKED ALL C ZONES
 9-26-88

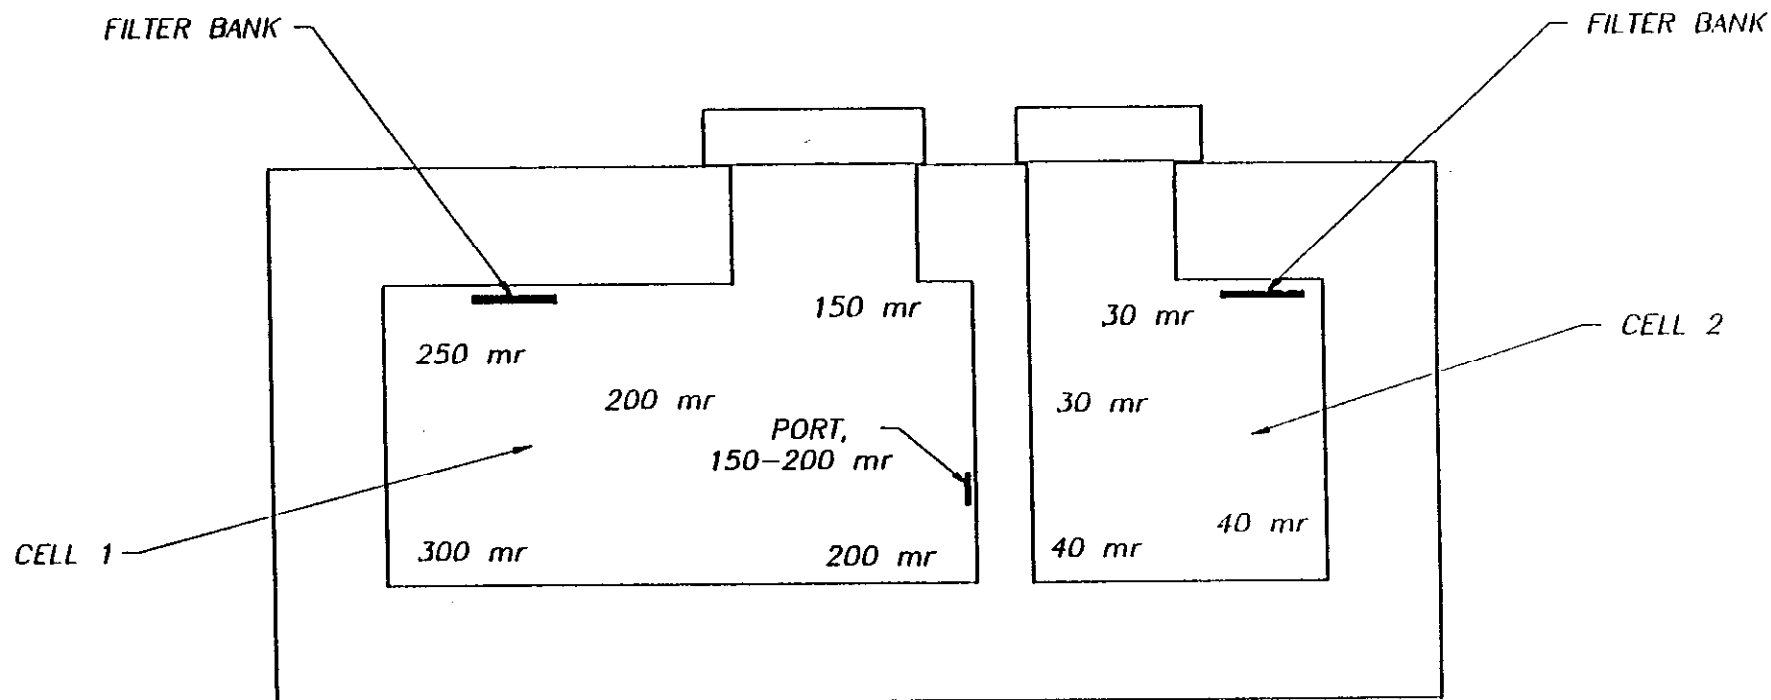
ARA HOT CELLS PLAN

FILTERS REMOVED 8/24/88

R. PERSKY EXPS. ≤ 5 mr FOR CELL ENTRY TO REMOVE FILTERS

FILTER READINGS

CELL 1		CELL 2	
1.	500 mr	1.	30 mr
2.	1 R/HR	2.	50 mr
3.	200 mr	3.	50 mr
4.	200 mr

GBF READINGS w/ RO-3A

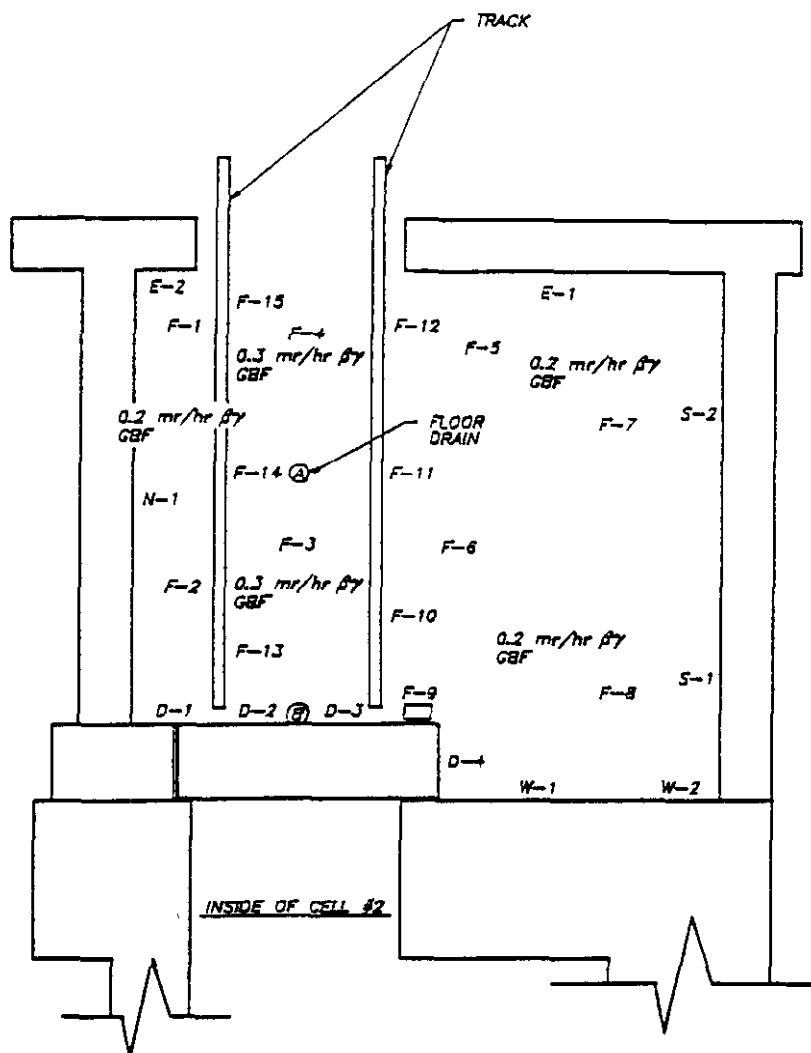
ARA HOT CELLS
CELL #2 SERVICE AREA PLAN

DIRECT RADIATION READINGS:

Ⓐ = 1 mr/hr by @ CONTACT w/ FLOOR DRAIN

Ⓑ = 3 mr/hr by @ CONTACT w/ DOOR BASE

ALL GBF READINGS TAKEN AT WAIST LEVEL w/ GM
SMEARS TAKEN WERE ≤ 300 c/m²

DOOR SMEARS d/m (by)

D-1	800
D-2	1,600
D-3	2,200
D-4	1,000

TRACK SMEARS d/m (by)

F-10	9,400
F-11	4,500
F-12	4,800
F-13	12,000
F-14	17,000
F-15	3,500

WALL SMEARS d/m (by)

W-1	800
W-2	700
S-1	2,800
S-2	4,300
E-1	1,100
E-2	880
N-1	1,600

FLOOR SMEARS d/m (by)

F-1	1,800
F-2	11,000
F-3	6,500
F-4	6,800
F-5	2,900
F-6	4,000
F-7	3,200
F-8	1,000
(DOOR GUIDE) F-9	11,600

ALL SMEARS TAKEN SHOWED < 20 d/m a

ZONE II G. LEVELS
WK 9-9-88

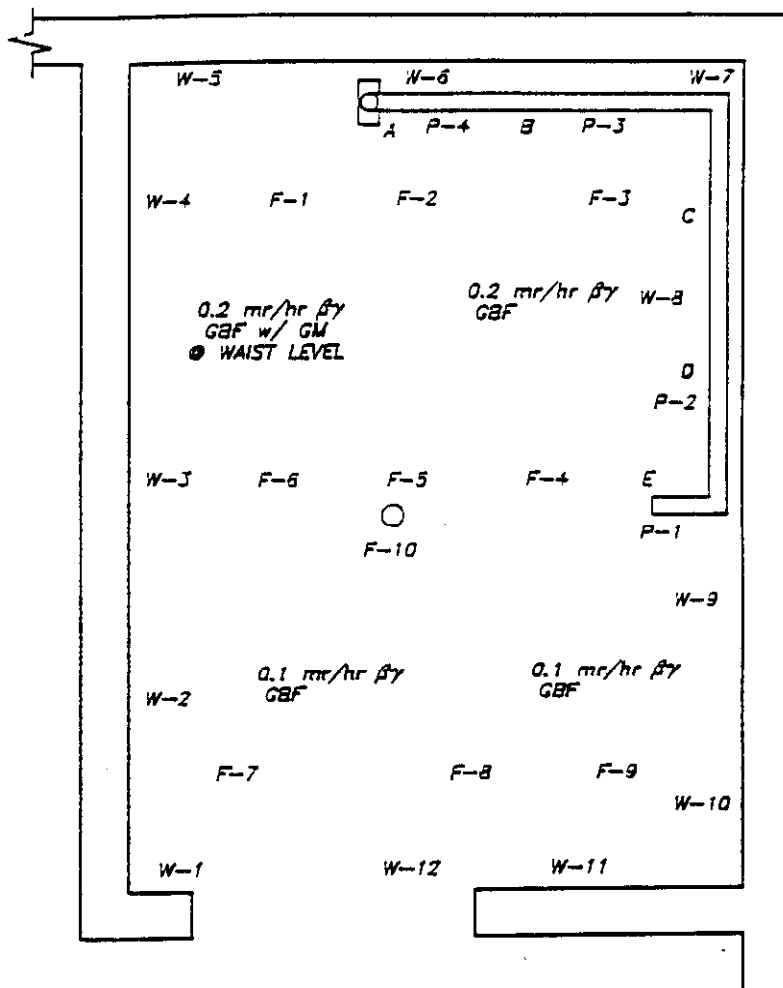
ARA HOT CELLS
RM #124--DECON. ROOM PLAN

NOTE: 10 BOXES OF C'd Pb BRICKS/SHEETING STACKED THRU CENTER OF ROOM. 1 BOX OF NON-C'd Pb ALSO PRESENT IN STACK. MAX. CONTACT READING PRESENT ON BOXES IS 0.3 mr/hr $\beta\gamma$ w/ GM. ALL BOXES SMEARED < 200 d/m $\beta\gamma$ / < 20 d/m α .

FLOOR SMEARS d/m $\beta\gamma$	WALL SMEARS d/m $\beta\gamma$	DRAIN PIPE mr/hr $\beta\gamma$	DRAIN PIPE SMEARS d/m $\beta\gamma$
F-1 1,540	W-1 <200	A 0.5	P-1 11,940
F-2 1,500	W-2 <200	B 13	P-2 6,160
F-3 6,380	W-3 220	C 0.5	P-3 2,740
F-4 780	W-4 <200	D 0.8	P-4 1,620
F-5 3,440	W-5 370	E 15	
F-6 6,000	W-6 8,600		
F-7 2,880	W-7 12,780	ALL READINGS MADE	
F-8 1,200	W-8 10,000	⊙ CONTACT w/ GM	
F-9 2,000	W-9 1,400		
F-10 3,120 (FLOOR DRAIN)	W-10 440		
	W-11 630		
	W-12 460

SMEARS WERE $\leq 300 \text{ cm}^2$ WITH MAX. α \leq OF 40 d/m NOTED.

- 4.2.24 Room 124 Decontamination Room: Removed the hood, sink and all miscellaneous equipment. All utilities have been shutoff and drained. There are eleven 2x2x1 wood boxes of contaminated lead bricks in this room. There are two yellow poly wrapped pieces of contaminated asbestos wrapped piping 12 ft long that could not be processed. The room is a Zone II (see attached radiation/contamination levels in this report as Appendix B). The HEPA filters have been removed and the piping capped and sealed. Filter doors were spot welded shut. The room door has been shut; sealed and padlocked.

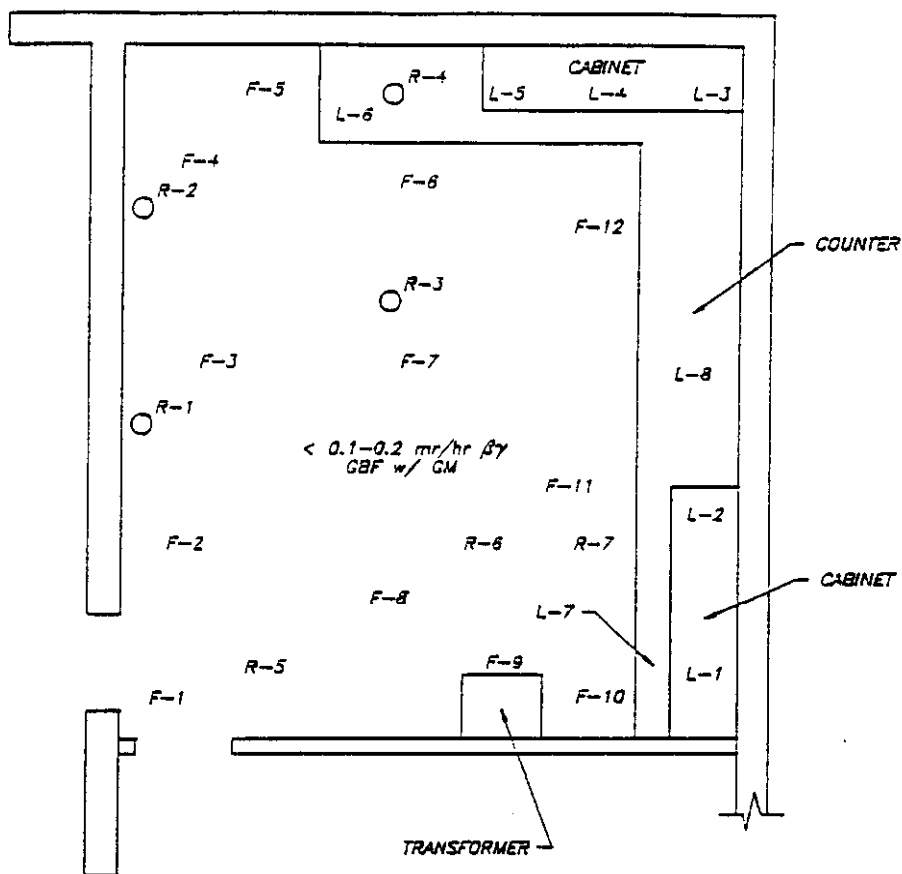
ARA HOT CELLS
 ROOM #125 PLAN
 9-23-88

DIRECT CONTACT READINGS w/ GM:

R-1 0.1 mr/hr βγ @ DRAIN LINE
 R-2 0.5 mr/hr βγ @ DRAIN LINE
 R-3 0.1 mr/hr βγ @ DRAIN LINE
 R-4 5.0 mr/hr βγ @ DRAIN LINE
 R-5 30 mr/hr βγ @ FLOOR -
 R-6 12 mr/hr βγ @ FLOOR
 R-7 10 mr/hr β @ FLOOR

FLOOR SHOWS FIXED C. OF 2,000-50,000 c/m βγ w/ 2A &
 ≤ 30 mr/hr βγ @ CONTACT w/ GM IN CRACKS BETWEEN TILES &
 ALONG WALL BASE BOARDS. NO α C. DETECTED ON FLOOR w/ PAC-4S.

FLOOR SMEARS d/m βγ

F-1 270
 F-2 210
 F-3 4620
 F-4 400
 F-5 0
 F-6 420
 F-7 250
 F-8 0
 F-9 330
 F-10 950
 F-11 510
 F-12 270

CABINET SWIPES c/m βγ w/ 2A (LARGE AREA)

L-1 200
 L-2 <100
 L-3 <100
 L-4 200
 L-5 300
 L-6 2,000
 L-7 <100
 L-8 150

NO α C. DETECTED w/ PAC-4S ON SWIPES

ALL FLOOR SMEARS
 < 20 d/m α / ≤ 300 c/m²

4.2.25 Room 125 Radiochemistry Lab: The lead brick has been removed. Removed all the equipment including hoods and glove boxes. Removed HEPA filters, capped and sealed-off the piping. Spot welded filter doors shut. Removed the sink trap but left the sink in place. Drained all plumbing in the room. The room is a Zone I. The window was covered with sheetmetal, the doors shut, sealed and locked (see attached radiation/contamination levels in this report as Appendix B).

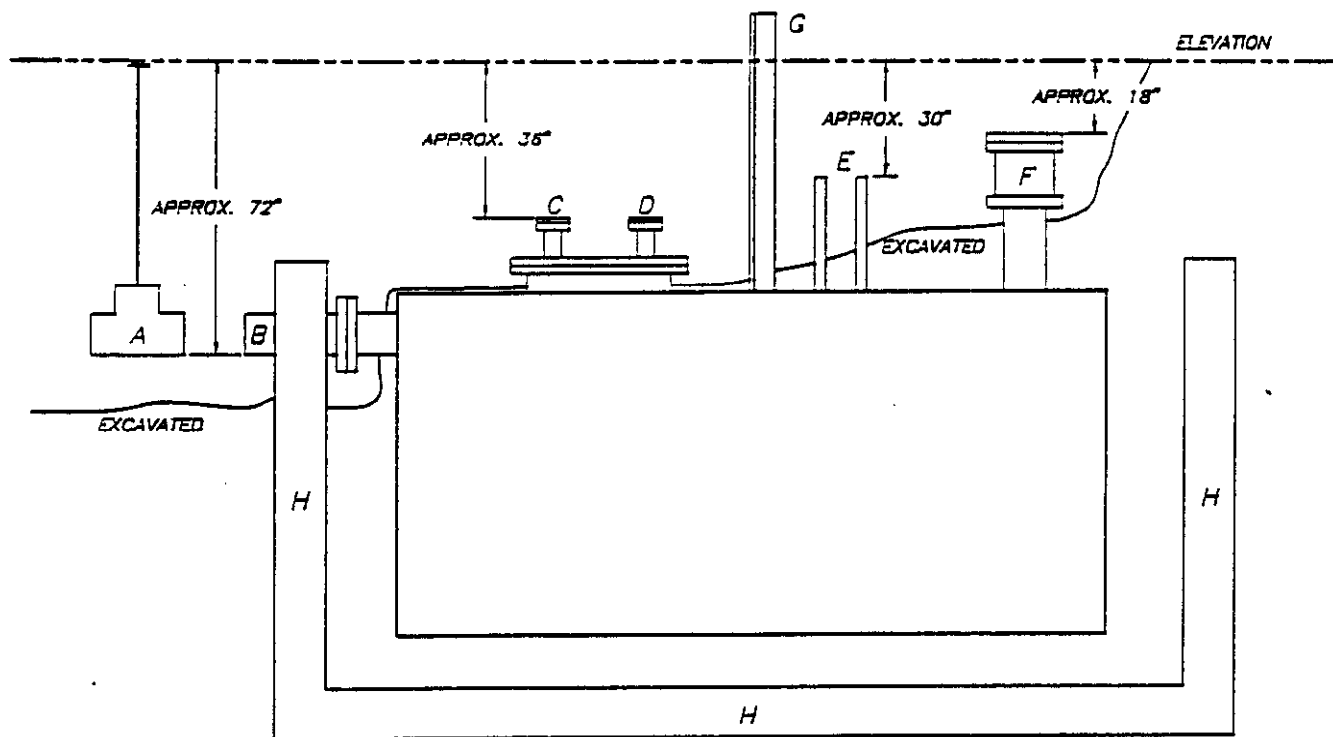
ARA HOT CELLS
 HOT WASTE CATCH TANK
 9-1-88

- A = ISOLATION VALVE, CUT & CAPPED, ≤ 500 mr/hr $\beta\gamma$ @ CONTACT, 50 mr/hr $\beta\gamma$ @ 2'-0"
 B = 4" INLET LINE, CUT & CAPPED, ≤ 300 mr/hr $\beta\gamma$ @ CONTACT
 C = 2" INLET LINE, BLIND FLANGED, 20 mr/hr $\beta\gamma$ @ CONTACT ($\leq 3,000$ c/m $\beta\gamma$ w/ 2A IN SOIL)
 D = 2" INLET LINE, BLIND FLANGED, 20 mr/hr $\beta\gamma$ @ CONTACT
 E = 1" INSTR. LINES, CUT & CAPPED, 10 mr/hr $\beta\gamma$ @ CONTACT
 F = 4" OUTLET PUMP HOUSING, BLIND FLANGED, 30 mr/hr $\beta\gamma$ @ CONTACT, $\leq 5,000$ c/m $\beta\gamma$ w/ 2A IN SOIL
 G = 2" ANGLE IRON, LEFT AS EXCAVATION GUIDE
 H = CONCRETE VAULT

NOTE: GBF VARIED FROM 5-30 mr/hr $\beta\gamma$ @ WAIST LEVEL WITH TANK EXPOSED, 2 R/HR $\beta\gamma$ WAS SEEN LEVEL WITH MANHOLE COVER WHEN REMOVED. GENERAL G LEVELS SEEN IN SOIL WERE 400-1000 d/m $\beta\gamma$ WITH SMEAR COUNTER EXCEPT FOR AT LOCATION C, D, & F.
 CONTACT READINGS A & B MADE w/ RO-3A, ALL OTHER READINGS MADE w/ GM.

4.3.2 Buried Hot Waste Tank: The pump and all external piping was removed from the tank. The soil was removed from the tank down to the large manhole and to the inlet pipe on the end of the tank. The inlet pipe was cut just outside the concrete bunker and both ends of the line were capped off. The manhole cover was removed and a sludge sample was taken from the bottom of the tank. Only about 3 in. of water/sludge remained in the bottom of the tank. The sample read 300 mr/hr and was sent for hazardous waste analysis. The manhole was recapped. Dug down along side the outlet pump line. There we found some soil contamination, so digging was terminated. The line was capped where the pump was removed. The tank was then reburied. Results of survey are in the attached radiation/containment notes. In order to dig around the tank, the inside portion of the tank enclosure fence had to be taken down. This was not replaced. The outside portion remains intact. The outlet line from the pump has asbestos covering; the piping was rapped and moved into the Decon Room 124. (See attached radiation/contamination levels in this report as Appendix B.)
